VCOM Firmware Chip Retrofit

Removal and Replacement of the VeriComm[®] Firmware Chip for IP-Compatible Control Panels

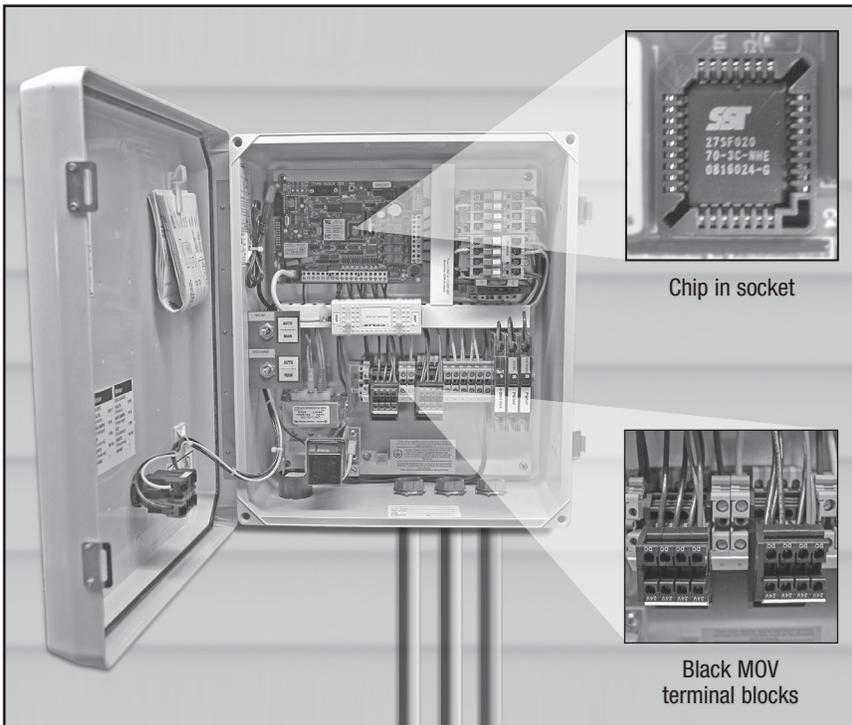
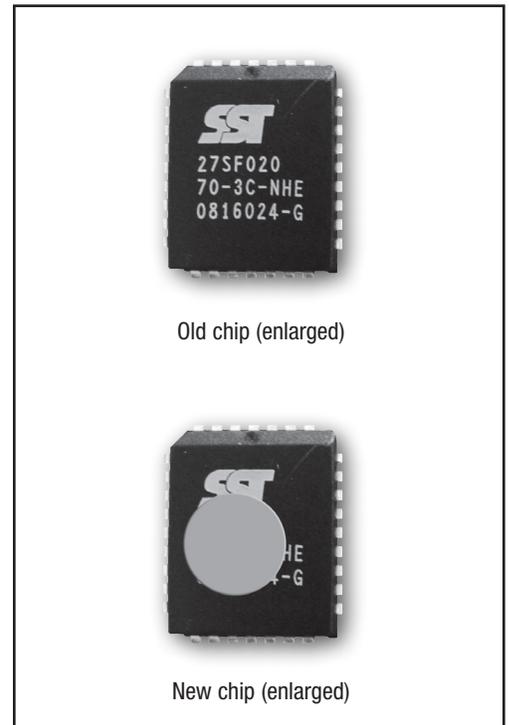
IP-compatible VCOM panels shipped from Orenco[®] between January 1 and October 1, 2008, have a bug in the panel's programming. When one of these IP-compatible panels is installed at a property with NO landline but a landline is ADDED LATER, the panel fails to recognize the new phone line, gets "confused," and won't call in. These IP-compatible panels can also get "confused" and stop calling in if the property owner stops phone service for several days or more, then starts it back up again.

IP-compatible VCOM panels shipped between January 1 and October 1, 2008, are easy to identify in the field. They have black terminal blocks. And the firmware's programming chip has writing on it but no green dot. Newer panels with the corrected programming also have black MOV terminal blocks. In addition, they have a green dot on the firmware chip. (See photos, below.) Replacement chips also have this green dot on them.

All panels shipped since October 1, 2008 have an updated firmware chip to correct this bug. To correct the bug in IP-compatible panels shipped before October 1, 2008, it is necessary to replace the panel's firmware chip with a new chip. Replacement chips and chip-extraction tools are available free of charge from Orenco, 800-348-9843, or from your local AdvanTex[®] Dealer. Chip replacement instructions are on the next page.
